## Communication Error Message

Spas with a sequencing system occasionally show a communication error message, or ----F, in the main upper control display window. This is a result of electrical “noise” which needs to be cleared out of the lower control system. You can fix this with a little time and patience. This process will work on spas with a sequencing system and a 7-button upper control panel, (see below), generally manufactured between 2002-2006.

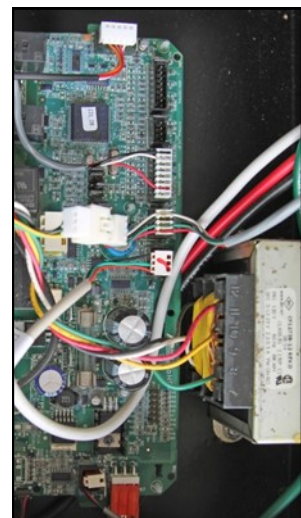
Remove the front cover of the lower control box to access the pc board inside. We are going to work on the right side of the printed circuit board. Find the 6 sockets on the edge of the pc board.

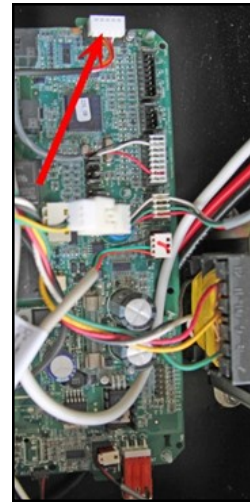
If there is a connector at P8, unplug it. (This is for an optional Handheld Remote Control System, which was a marginally good idea and almost no one bought). We won't be plugging this connector back in later.

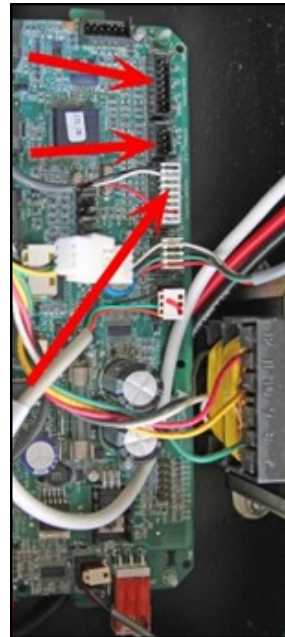
Step 4

Unplug any connectors at P1 – Main Control, P2 – EXT, and P3 – Aux Control.

Reattach any connectors at P1, P2, and P3. (Do not plug connector at P8 again.)

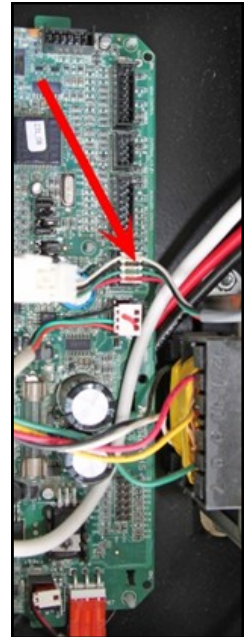
Step 5

Unplug the connector at P4.

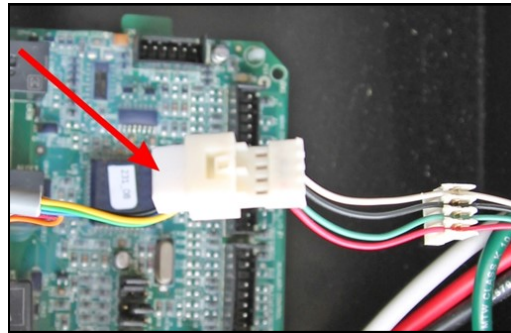
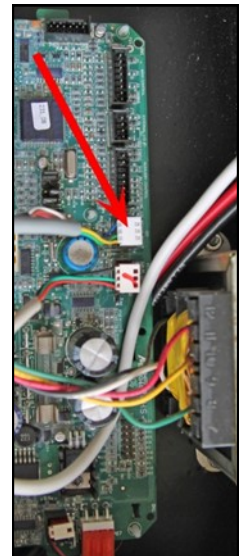
When you unplugged the piece at P4, you noticed a few inches of wire and a coupler. (We'll call that extra wire and coupler a "pigtail"). There is a connector that plugs into the coupler from the left side. This comes from the main upper control keypad. Separate it from the coupler and plug it directly onto P4.

Put everything back together as it originally was at P4.

- A. Reconnect the original connector at P4.
- B. Reattach the end of the pigtail and main upper control keypad connector together.
